NATIONAL TRANSPORTATION SAFETY BOARD

RAILROAD ACCIDENT REPORT

DERAILMENT OF UNION PACIFIC RAILROAD TRAIN
QFPLI-26 AT EUNICE, LOUISIANA, MAY 27, 2000

**NTSB/RAR-02/03
PB2002-916303
Notation 7450
Adopted April 2, 2002**

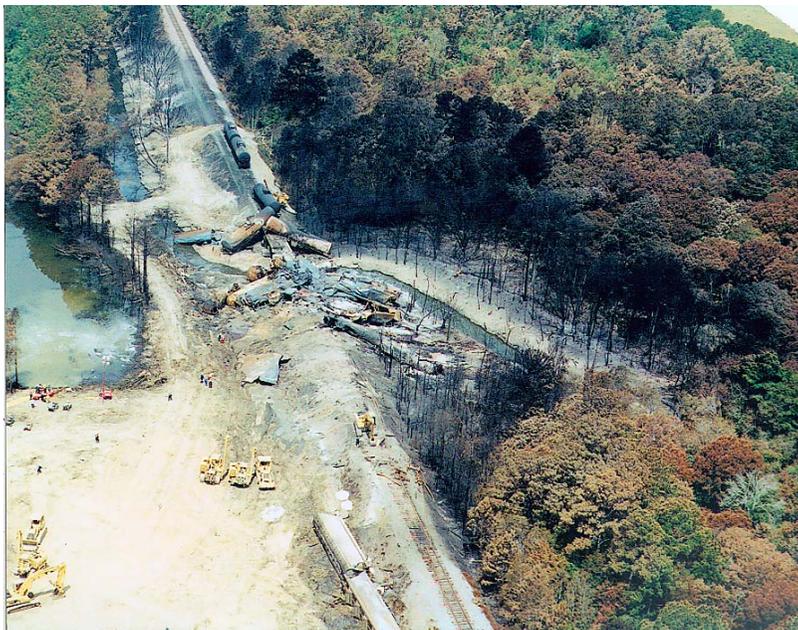
Figure 1. Looking west at accident scene.

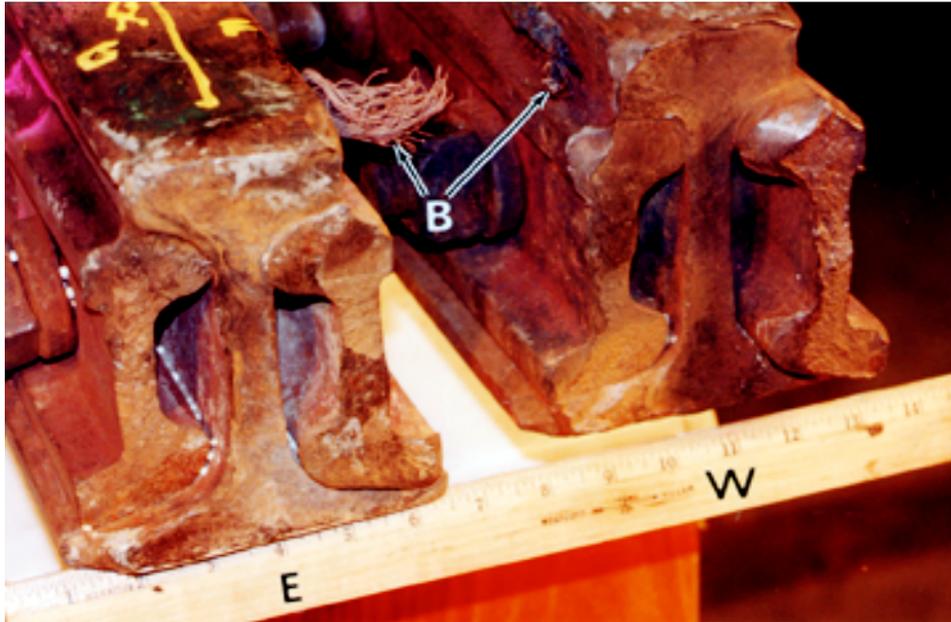
During the postaccident inspection of the derailment area, portions of two broken joint bars, still bolted to the end of a section of the south rail, were found on the bridge at about the fourth span. Each joint bar portion had a break in the transverse plane at the center of the joint bar, near the end of the rail. Later, portions of another pair of broken joint bars were found. These bars also had remained bolted to a piece of rail and had breaks in the transverse plane at the center of the joint bar. The fractured surfaces of the two pairs of broken joint bar pieces matched one another in both the location of the broken surfaces and the type of fracture.

Raised characters on each joint bar identified the bars as having been manufactured in 1951 by the Colorado Fuel & Iron Corporation. Although some of the fracture surface was obliterated by postfracture damage, a portion of the remaining fracture surface of each joint bar showed the chevron patterns and radial marks that are typically found in overstress fractures. From these markings, the initiation of the overstress region in each bar could be traced to a relatively smooth, dark region with a curving boundary, which is typical of fatigue.

Figure 6. The accident joint bars. The east and west sections of the joint bars are indicated by “E” and “W.” The location of the bond wires is indicated by “B.” The bond wires are on the field side (outside) of the joint.

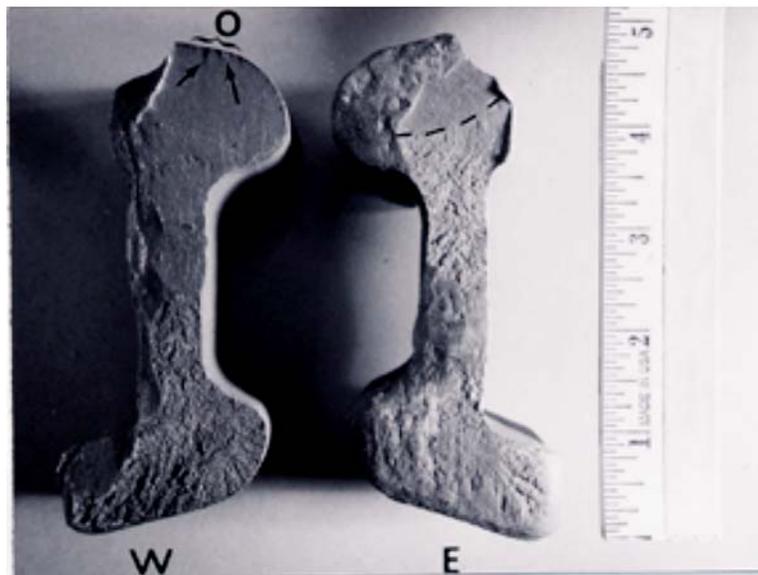
On the field-side joint bar shown in figure 7, the fatigue region was on the upper portion. A portion of the boundary was visible on the east surface, as indicated by the dashed line. Ratchet marks were visible on the west surface, indicating multiple origins at the top of the bar in the area marked by bracket "O." The depth of the fatigue region was approximately 0.813 inch. On the gage-side joint bar shown in figure 8, the fatigue region was on the lower gage-side corner of the bar. For each mating surface shown in figures 7 and 8, a dashed line indicates the fatigue boundary, and bracket "O" indicates the fatigue origin area. The depth of the fatigue region was approximately 0.308 inch.

Figure 7. The field side (outside) joint bar from the accident joint. The area of the fatigue crack boundary is shown as a dashed line. The letter “O” indicates the fatigue origin area.

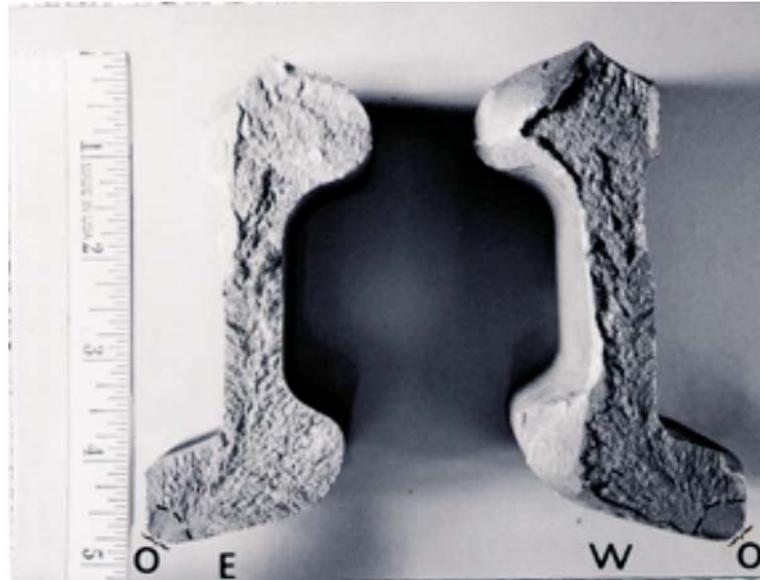
Figure 8. The gage side (inside) joint bar from the accident joint. The area of the fatigue crack boundary is shown as a dashed line. The letter “O” indicates the fatigue origin area.

An examination of the surface of the fractured areas of the joint bars revealed that both fractured surfaces displayed evidence of contact damage to the mating fractured surface. In general, the greater damage was on the field side of the west surfaces and on the gage side of the east surfaces, indicating that the separated joint bars had shifted in relation to each other after they had fractured.
