U.S. DEPARTMENT OF COMMERCE
Office of Inspector General

**NATIONAL OCEANIC AND
ATMOSPHERIC ADMINISTRATION**

***Acquisition of NEXRAD Transition Power
Source Marred by Management, Technical,
and Contractual Problems***

Final Inspection Report No. OSE-15676/September 2003

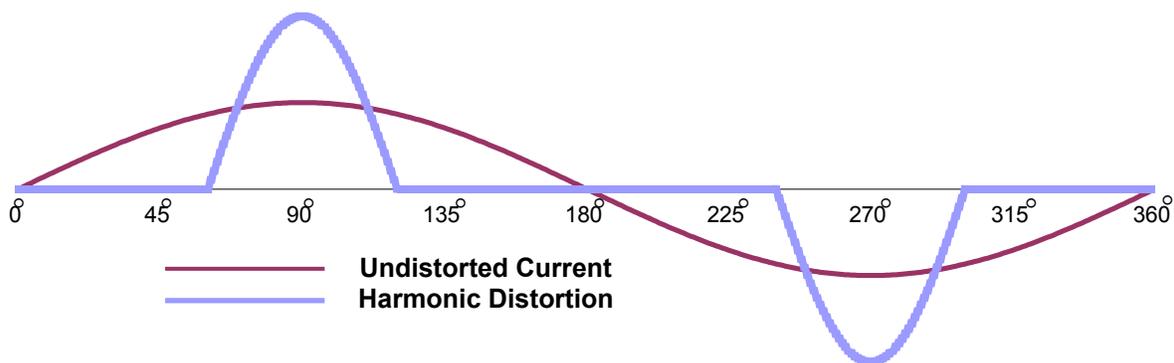
A major challenge in the design of electric power systems is controlling reflected harmonic distortion (see figure 3). Static TPS technology available when the ROC performed its initial engineering assessment used a 6-pulse silicon controlled rectifier (SCR). This technology produces high levels of harmonic currents or harmonic distortion, which can be reflected back to the power source, including to the engine generator, and cause high voltage distortion. Consequences of high current and voltage distortion include overheating of conductors and motor windings, and instability in voltage and frequency regulation. Other potential effects include reduced efficiency and service life of the engine generator, as well as problems with other system components such as power supplies, variable speed motors, power factor improvement or filter capacitors, air conditioner controls, and in severe cases, cables and wiring. Total harmonic distortion (THD) is the measure used to define the effect of harmonic distortion on power system voltage or current.

Figure 3: Example of Harmonic Distortion
Undistorted alternating current has the shape of a sine wave. In the U.S., alternating current is usually generated at a frequency of 60 hertz, called the fundamental. Harmonic distortion is any deviation of current or voltage from the fundamental and has a frequency that is an exact multiple of 60 hertz. Nonlinear loads—such as the 6-pulse SCR—draw a nonsinusoidal current when supplied by a sinusoidal voltage source and produce harmonic distortion.

Because of the importance and complexity of controlling harmonics, the Institute of Electrical and Electronics Engineers (IEEE) developed Standard 519-1992, *IEEE Recommended Practices and Requirements for Harmonic Control in Electrical Power Systems*, to guide the design of power systems with nonlinear loads.^{22,23} Systems incorporating 6-pulse SCR units often oversize the engine generator as a means of avoiding harmonic heating and instability. However, one of the constraints placed on the selection of TPS technology for NEXRAD was that—to avoid additional costs—existing engine generators were not to be replaced. Based, in part, on the technology available for assessment at the time the ROC performed its initial engineering analysis and on the engine generator sizing issues, ROC engineers concluded that static technology probably was not feasible using a commercial product. The IEEE standard, as applied to NEXRAD, establishes a maximum limit of 5 percent for current THD, and consistent with this standard, the original TPS specification allowed a maximum current THD of 5 percent.

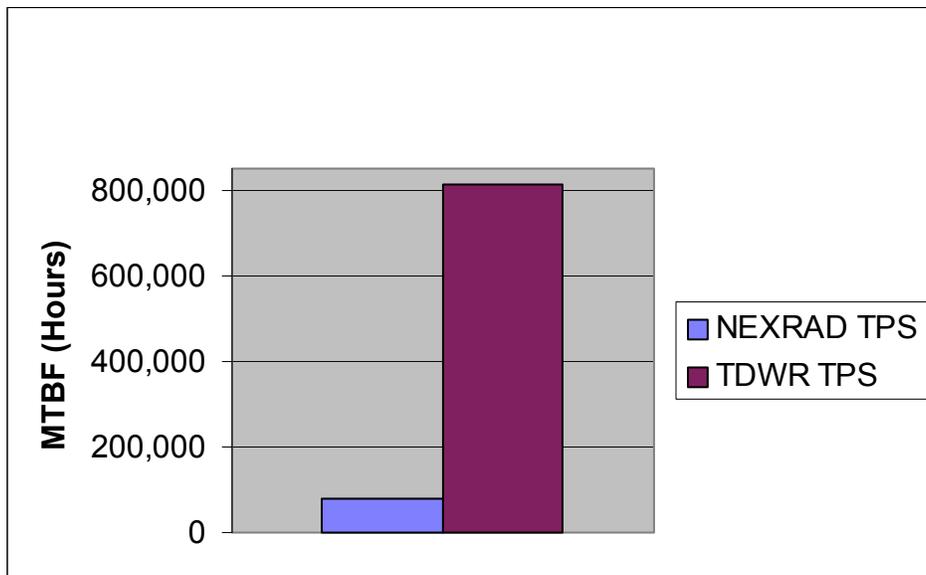
Figure 4: Comparison of Mean Time Between Failure for NEXRAD and TDWR Static TPS

Furthermore, a comparison of the reliability data collected by FAA and NWS indicates that FAA’s static TPS is far more reliable. As of January 6, 2003, TDWR TPS units had experienced 2 relevant failures in more than 1.6 million hours of operation,²⁶ while as of January 31, 2003, NEXRAD static TPS units had 19 relevant failures in fewer than 1.5 million hours of operation.²⁷ As shown in figure 4, the mean time between failure (MTBF) for the NEXRAD TPS is more than a full order of magnitude less than that of the TDWR TPS (over 800,000 hours for FAA’s TDWR units as compared to less than 80,000 for those of NWS).
