# NATIONAL TRANSPORTATION SAFETY BOARD

## HIGHWAY ACCIDENT REPORT

GREYHOUND MOTORCOACH  
RUN-OFF-THE-ROAD ACCIDENT  
BURNT CABINS, PENNSYLVANIA  
JUNE 20, 1998

**National Transportation Safety Board. 2000. *Greyhound Motorcoach Run-off-the-Road Accident, Burnt Cabins, Pennsylvania, June 20, 1998. Highway Accident Report NTSB/HAR-00/01.* Washington, DC.**

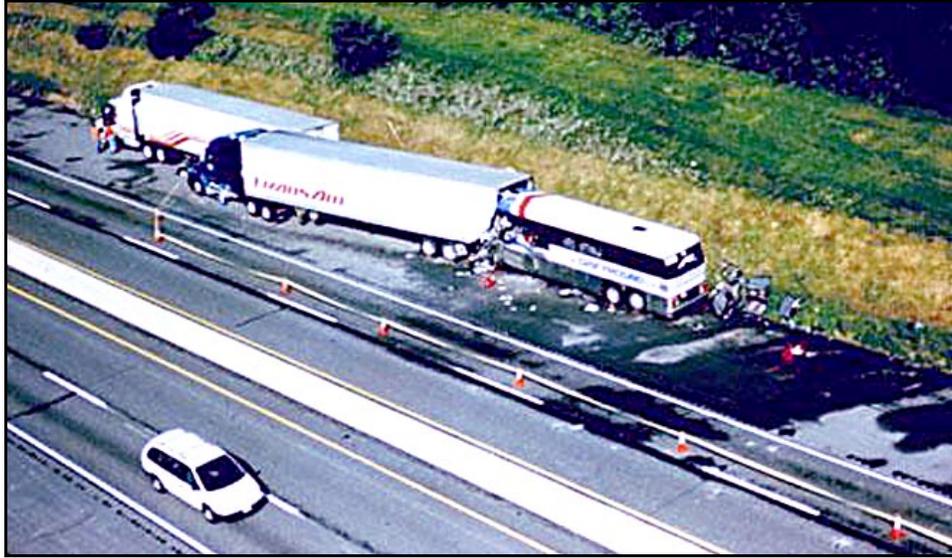
**Figure 2.** View of accident.

As the bus approached MP 184.9, it traveled off the right side of the roadway, at a departure angle of between 3 and 4 degrees, into an “emergency parking area” and struck the back of a TransAm Trucking Incorporated (TransAm) parked tractor-semitrailer, which was pushed forward and struck the left side of an Oliver Trucking Incorporated (Oliver) tractor-semitrailer, parked in front of the TransAm vehicle. (See appendix B for information on the TransAm and Oliver vehicles.)

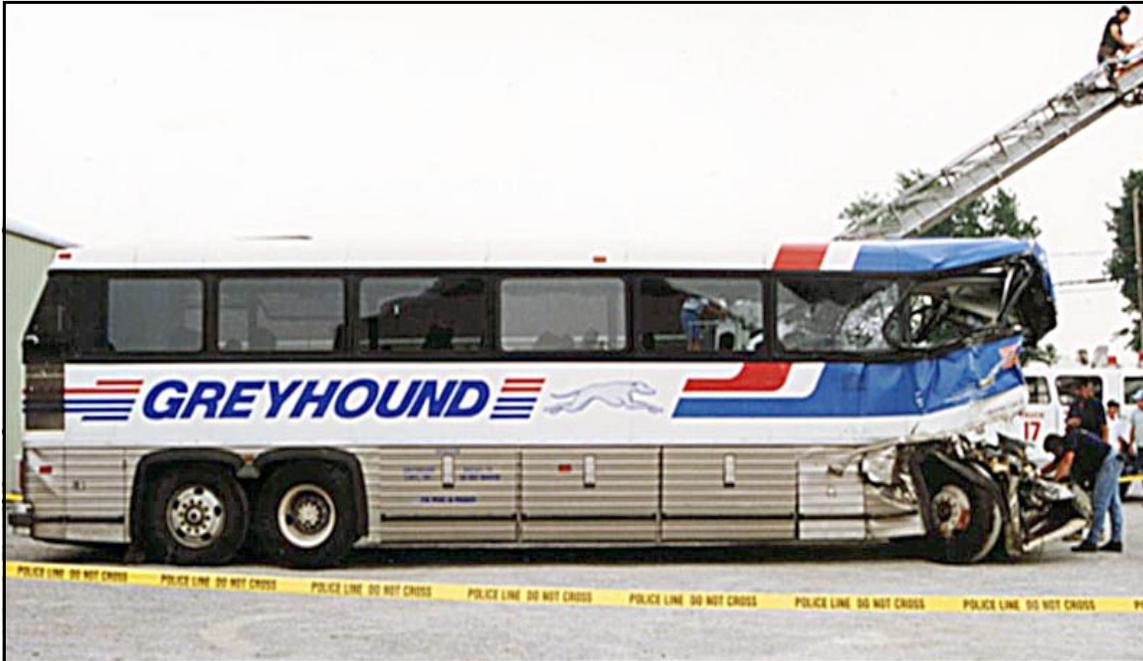
Figure 4. Exterior of damaged accident bus.

The coach sustained substantial front-end damage and intrusion. (See figure 4.) Maximum right frontal intrusion was measured about 8 1/3 feet in the area of the floor line. The right front wheel assembly had been displaced rearward approximately 1 1/2 feet. The front bumper had been separated from the vehicle. The lower right front of the vehicle was displaced rearward about 1 3/4 feet and skewed upward approximately 1 foot. The roof along the right side had been displaced rearward 2 3/4 feet and was skewed downward. Maximum left frontal intrusion had occurred in the area of the windows; rearward displacement was about 9 feet. The left front leading edge of the roof was displaced rearward 2 feet and was skewed down and inward. The area of the front bumper mounts was displaced rearward 2 feet. Cutting tool-type damage was observed on the left side near the third and fourth windows with the cut section of the body panel pulled downward. The left front wheel assembly had been displaced rearward approximately 1 inch.

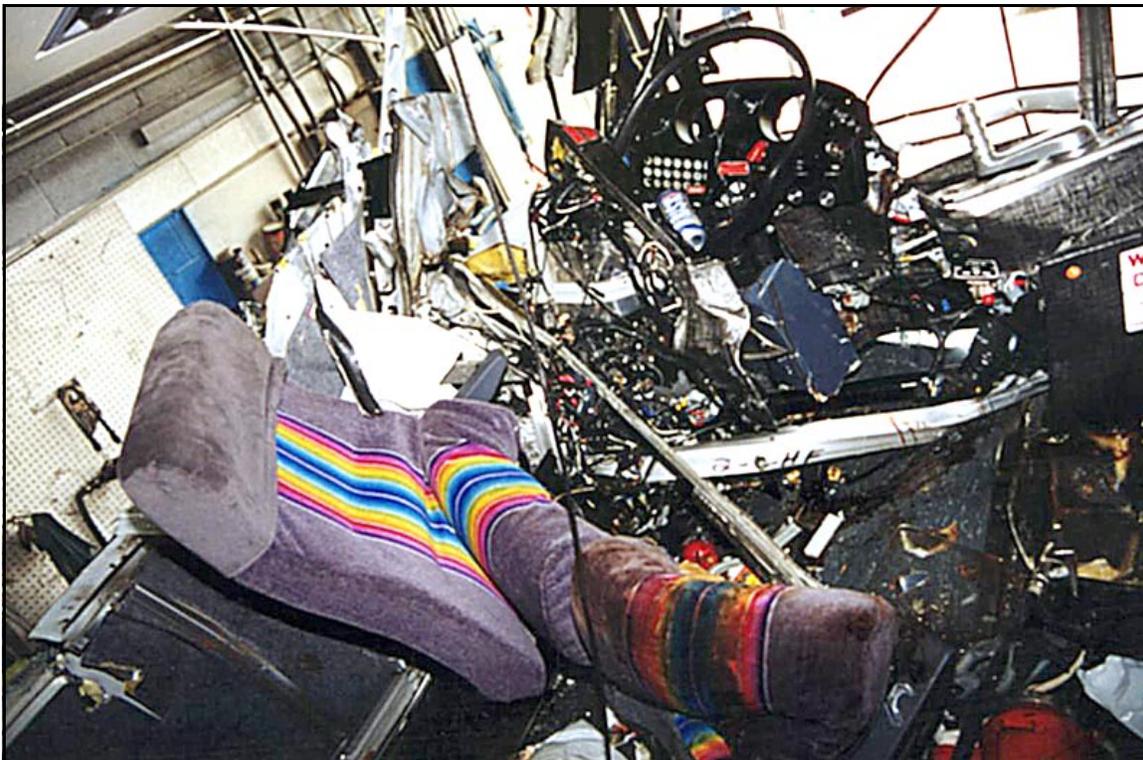
Figure 5. Interior left-side (driver) crush damage.

The coach's windshield was destroyed. The wiper arms were in the off position, as were the left and right windshield wiper control knobs. The steering wheel had been displaced rearward approximately 5.75 feet. The driver seat was not in place due to crush deformation rearward to the second row of passenger seats. (See figure 5.)

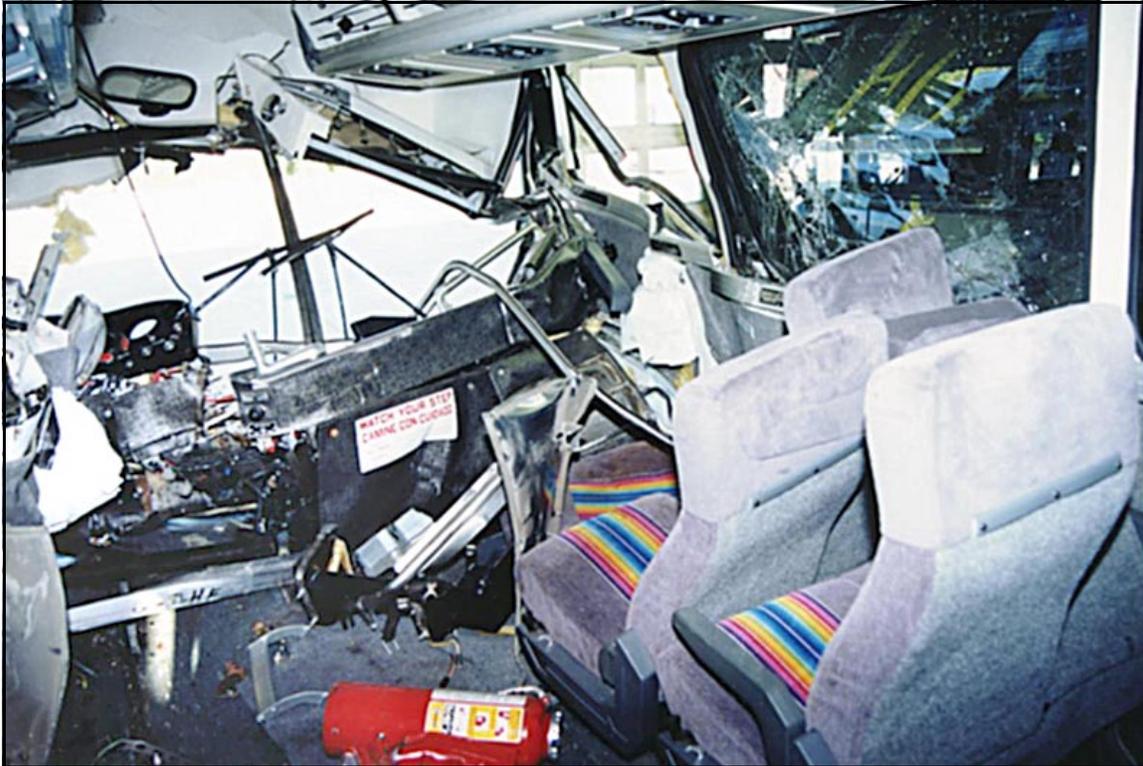
**Figure 6.** Interior right-side loading door and seat damage.

The coach was equipped with seven top-hinged emergency exit side windows on each side, excluding the driver's side windows. The passenger windows were 54 inches wide by 30 inches high. At the time of inspection, the first through third windows (front to rear) on the left side were missing; the fourth through seventh windows were intact and operational as emergency exits. On the right side, the first window was missing, the second was shattered, and the remaining windows were intact. The third window did not operate as an exit due to damage; the fourth window sustained structural damage and did not close, and its exit handle was blocked by a seat back. The remaining windows were operational as exits.

The coach had 11 rows of passenger seats, including the three-seat bench in the rear, which was intact. On the left side of the bus, the row-two seats were severely deformed, and the seats from rows three through five were found in the luggage compartment under the bus body. The row-six aisle seatback sustained inward deformation, while the row-seven aisle seat was rotated clockwise 10 degrees. The row-eight seatback cushions showed no evidence of impact marks, and the row-nine window seatback cushion was broken. At row 10, impact marks were on the aisle seatback cushions. On the right side of the bus, the passenger loading door was missing due to crush damage, which extended rearward to row two (see figure 6), and was found in the lower luggage compartment. Row three was crushed rearward into row four. From row 4 rearward through row 11, the seat frames were intact with some deflection of the seatback cushions. The window seats in rows four through eight were pushed forward and outward, with deformation to the rear of the seat below the level of seatback. Rows 9 through 10 were found relatively intact, without rear seatback deformation.

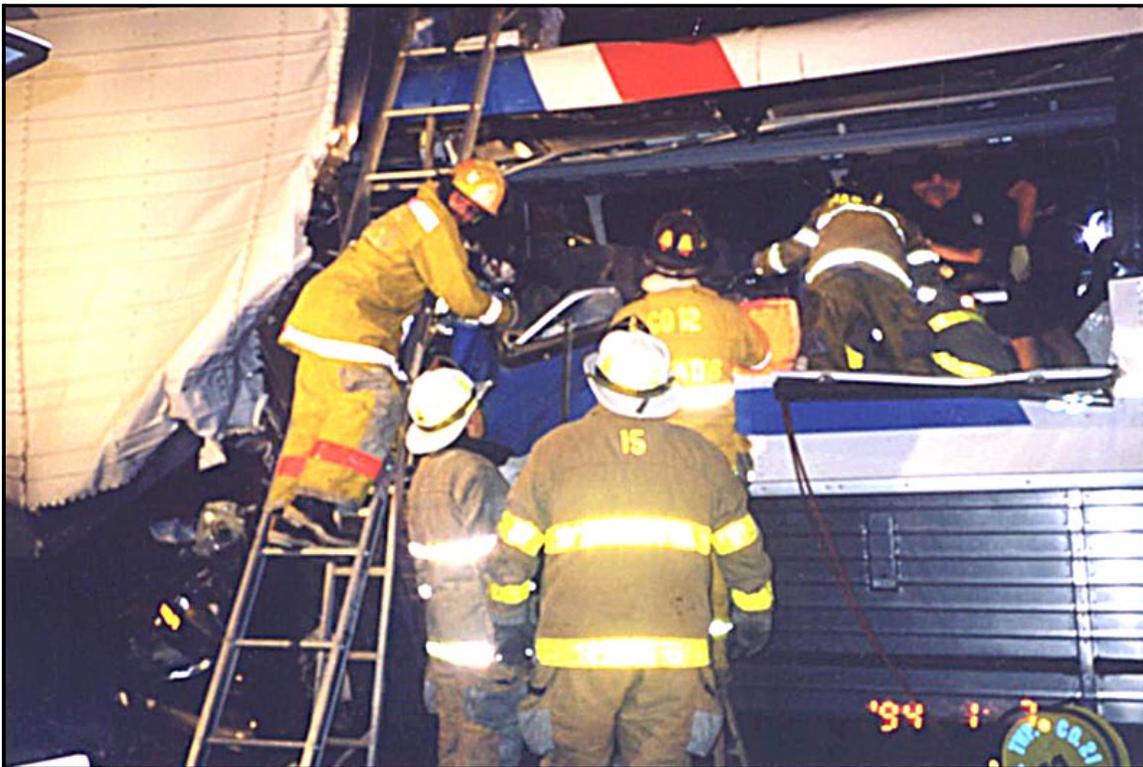
**Figure 9.** Outside left side of accident bus with emergency responders.

When the emergency responders arrived, they set up a step ladder (see figure 9), which the other Greyhound busdriver who had stopped at the accident scene used to climb into the bus and open the emergency windows. He then showed the responders how to use the extrication tools to remove the windows to gain access to the bus to reach the injured. He stated that he had trouble with visibility inside the bus because “it was pitch black and you couldn’t see.” The IC said that had the other Greyhound busdriver not been present to point out where the exits were, the lack of markings on the outside of the bus to indicate the exits would have been a hindrance.
