NATIONAL TRANSPORTATION SAFETY BOARD

RAILROAD ACCIDENT REPORT

DERAILMENT OF UNION PACIFIC RAILROAD TRAIN
QFPLI-26 AT EUNICE, LOUISIANA, MAY 27, 2000

**NTSB/RAR-02/03
PB2002-916303
Notation 7450
Adopted April 2, 2002**

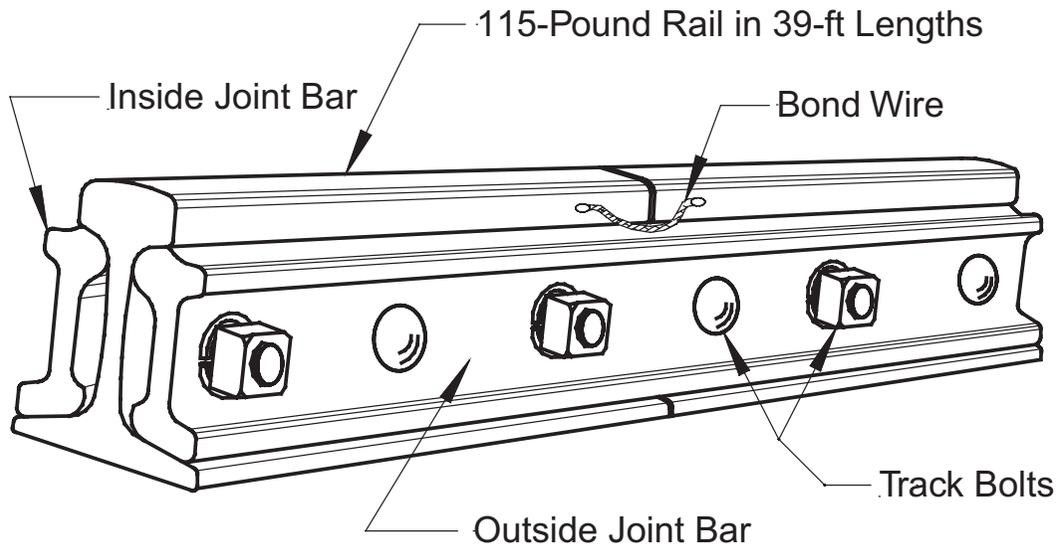
Figure 5. Sketch of a typical joint bar.

In jointed rail territory, the individual rails are joined to one another by joint bars. (See figure 5.) The Beaumont Subdivision used a common form of rail joint that consists of two joint bars plus six track bolts, nuts, and spring washers. Two joint bars, one on each side of the rail ends, are considered to be a pair. Oval-shouldered track bolts, typically 1 inch in diameter, are arranged in an alternating pattern through holes in the joint bars and rail. When the bars are matched up to form a rail joint, one on the gage side and one on the field side of the rail, the bolts are tightened and the joint bars are drawn toward each other, squeezing them toward the side of the rail. In addition to joining the rail ends together, the joint bars act as a beam that distributes over several adjacent ties the downward vertical load that is imposed on the rail joint by the weight of the train.

During the postaccident inspection of the derailment area, portions of two broken joint bars, still bolted to the end of a section of the south rail, were found on the bridge at about the fourth span. Each joint bar portion had a break in the transverse plane at the center of the joint bar, near the end of the rail. Later, portions of another pair of broken joint bars were found. These bars also had remained bolted to a piece of rail and had breaks in the transverse plane at the center of the joint bar. The fractured surfaces of the two pairs of broken joint bar pieces matched one another in both the location of the broken surfaces and the type of fracture.
