# NATIONAL TRANSPORTATION SAFETY BOARD

## HIGHWAY ACCIDENT REPORT

GREYHOUND MOTORCOACH  
RUN-OFF-THE-ROAD ACCIDENT  
BURNT CABINS, PENNSYLVANIA  
JUNE 20, 1998

**National Transportation Safety Board. 2000. *Greyhound Motorcoach Run-off-the-Road Accident, Burnt Cabins, Pennsylvania, June 20, 1998. Highway Accident Report NTSB/HAR-00/01.* Washington, DC.**

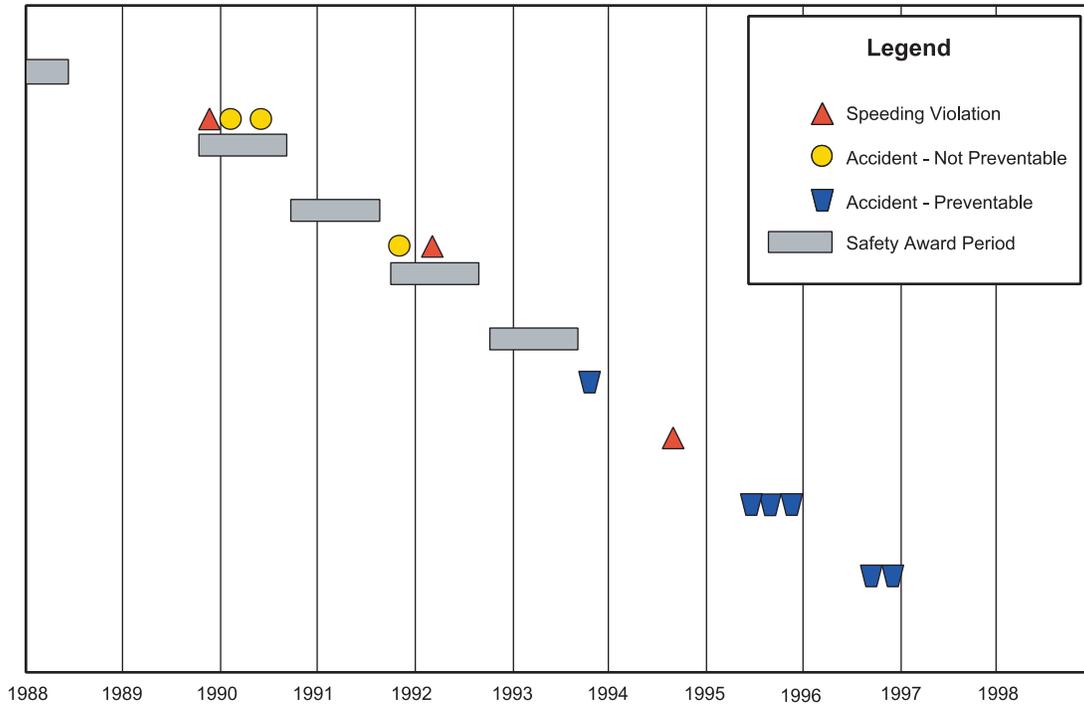
**Figure 7.** Chart of busdriver's driving record.

<sup>22</sup> The records of other interstate carriers' busdrivers are not stored in a central repository. Individual companies retain their drivers' records, making it difficult to obtain information to compare the accident driver's record with other interstate carrier busdrivers. However, according to the Greyhound safety director, the accident busdriver's record was a little below average when compared with the other Greyhound busdrivers' records.

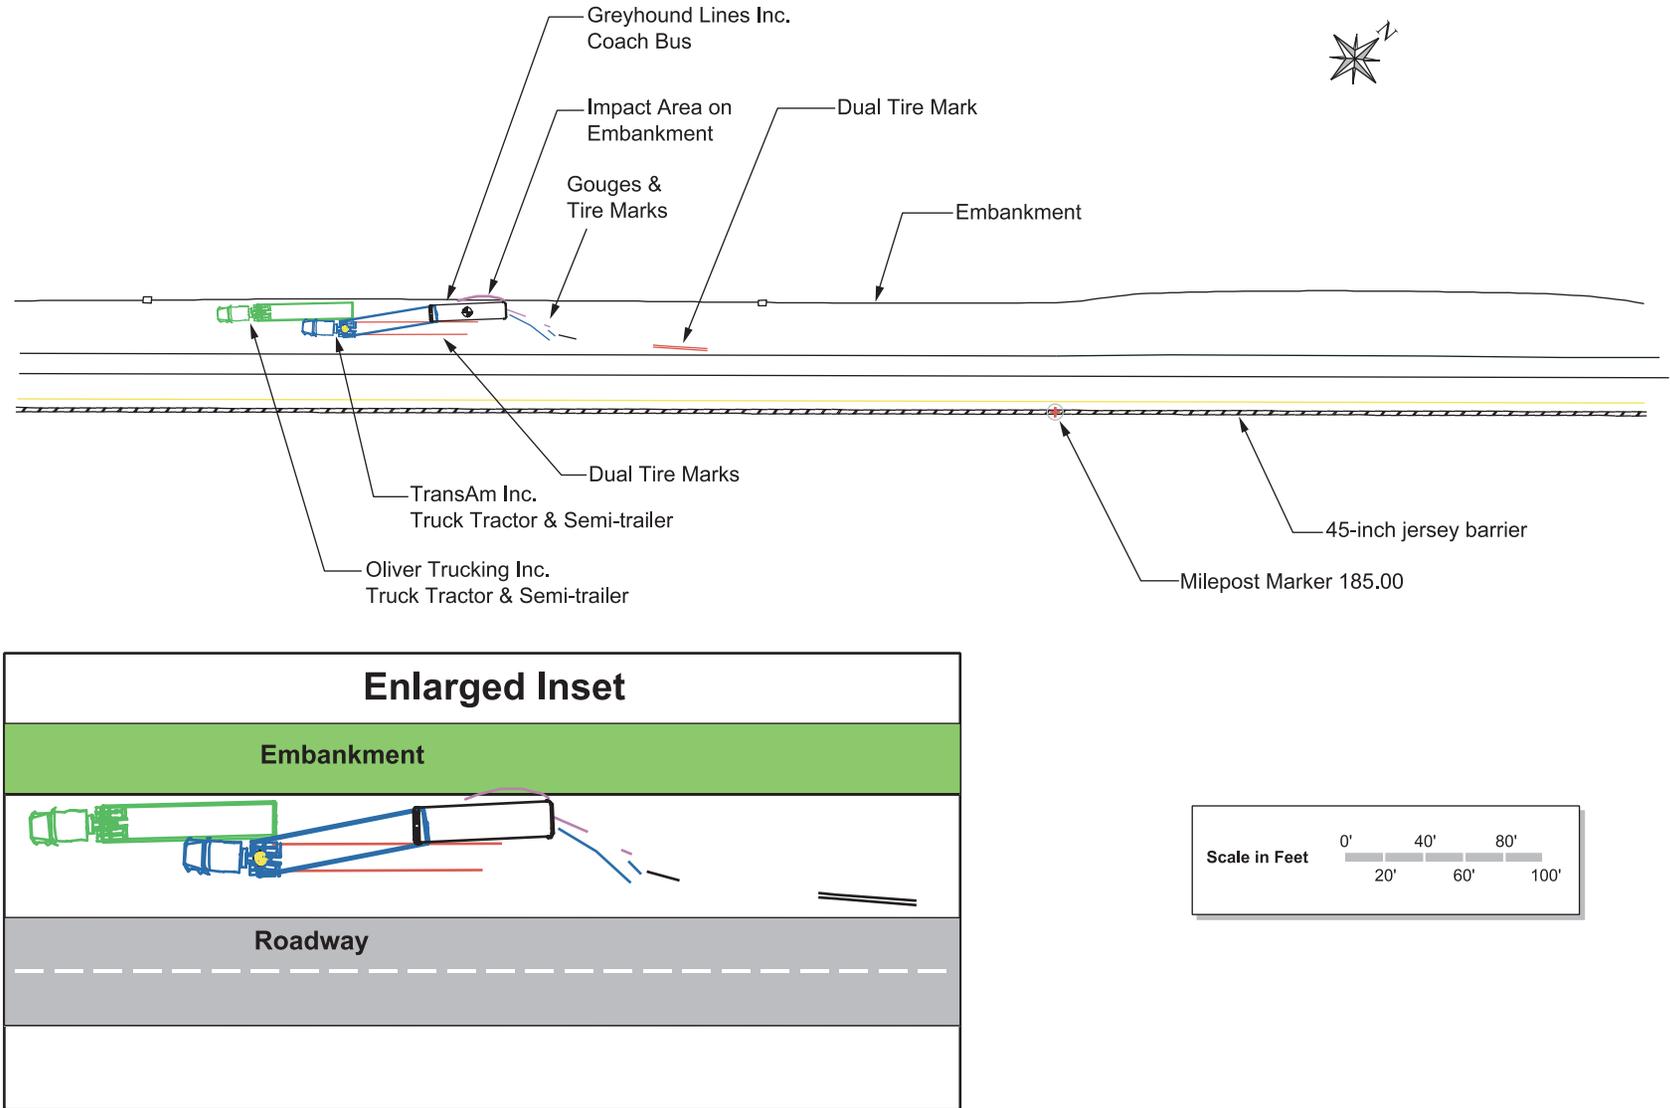
Figure 8. Accident scene diagram.

Tire marks, approximately 28 feet long, at the accident site had a departure angle from the roadway between 3 and 4 degrees. The tire marks started about 170 feet west of MP 185 (see figure 8). Approximately 39 feet of gouges and scrub marks were observed on the shoulder pavement, as well as an impact mark on the earthen embankment. In addition, 61-foot-long tire marks from the TransAm tractor-semitrailer's precollision parked position to its postcollision position were identified. The PSP surveyed the accident scene and the final rest positions of the accident vehicles.

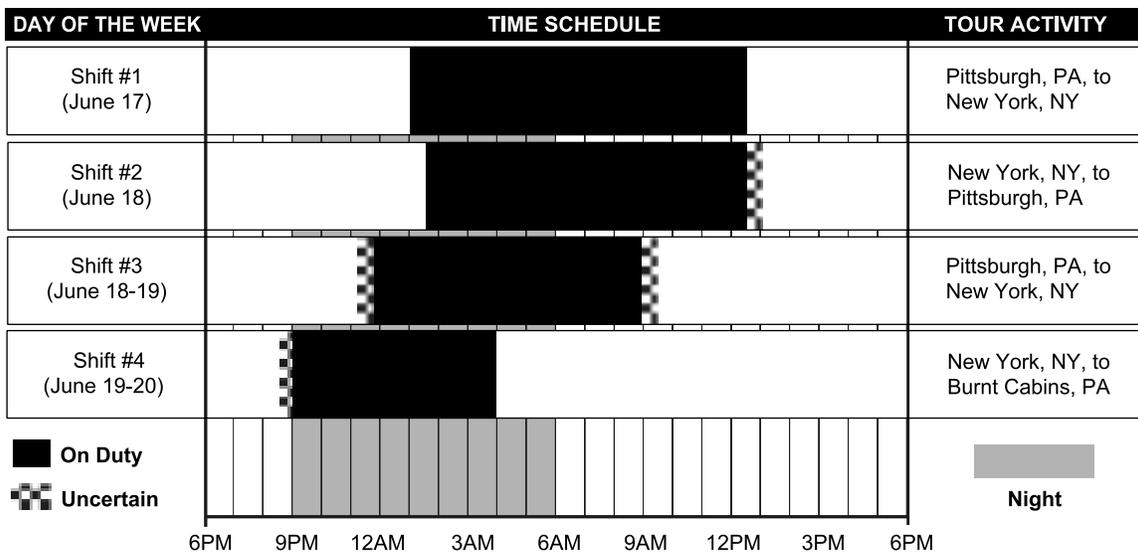
**Figure 10.** Chart of shift schedule.

**Driver’s Work Schedule.** The schedule selected by the busdriver resulted in an irregular work-rest cycle. The busdriver’s on-duty time commenced anywhere between 9:00 p.m. and 1:30 a.m., and his off-duty time began anywhere between 9:00 a.m. and 12:30 p.m. (See figure 10.) The Safety Board has previously addressed the issue of operator fatigue involving irregular work-rest schedules in its 1995 safety study on heavy truck accidents.<sup>47</sup> In the subset of these accidents for which sleep data were available, the Safety Board found about 67 percent of the drivers (43 of 64) with irregular schedules were involved in fatigue-related accidents, compared with about 38 percent of drivers (9 of 24) with regular schedules. The Safety Board found that irregular schedules could result in more hours awake than normal and, without careful planning, prevent drivers from obtaining adequate sleep.

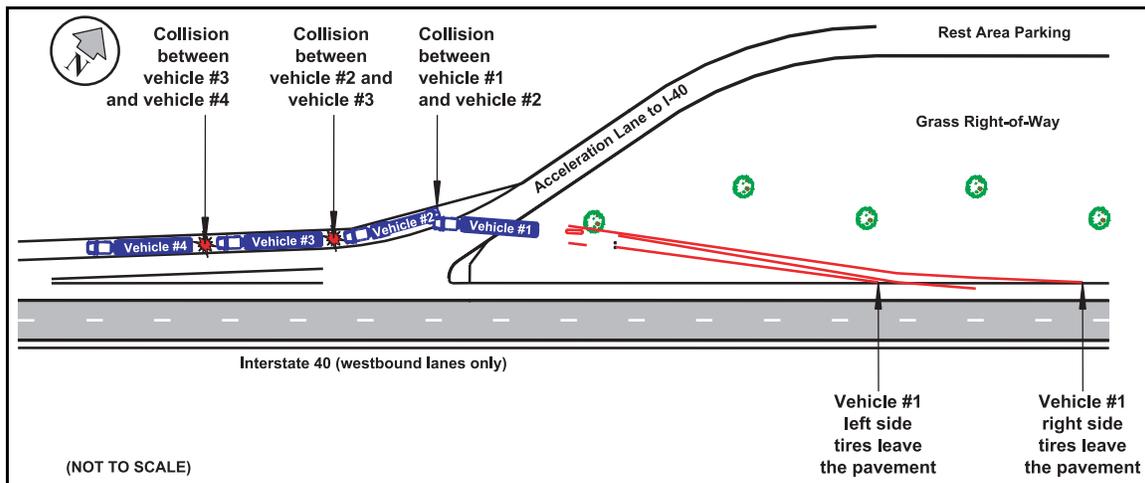
**Figure 11.** Diagram of truck tractor-semitrailer collision near Jackson, Tennessee.

their trucks' speed may be significantly lower than that of the traffic on the main roadway. Second, it creates a dangerous dilemma between high-speed vehicles decelerating into or accelerating out of the rest area and slow-moving vehicles pulling out from parking on the shoulders. Finally, the shoulders are not protected from errant vehicles. While truckdrivers may consider that this is a protected site due to the gore<sup>68</sup> areas that separate the ramps from the mainline, the following accident (depicted in figure 11) illustrates differently. On June 3, 1999, a westbound truck tractor-semitrailer approaching a public rest area on I-40 near Jackson, Tennessee, left the roadway, traveled 360 feet across a 63-foot-wide gore area, and struck three combination vehicles. These trucks were parked in an unauthorized area along the outside shoulder of the acceleration lane leading from the rest area onto I-40. The collision resulted in five fatalities.<sup>69</sup>
